**Evaluation of DOE Report:  
*Annual Report in Support of Compliance Plan No. CP-50284-000*, April 1, 2005**

**Effectiveness of the Perched Aquifer Pump and Treat System  
December 2005**

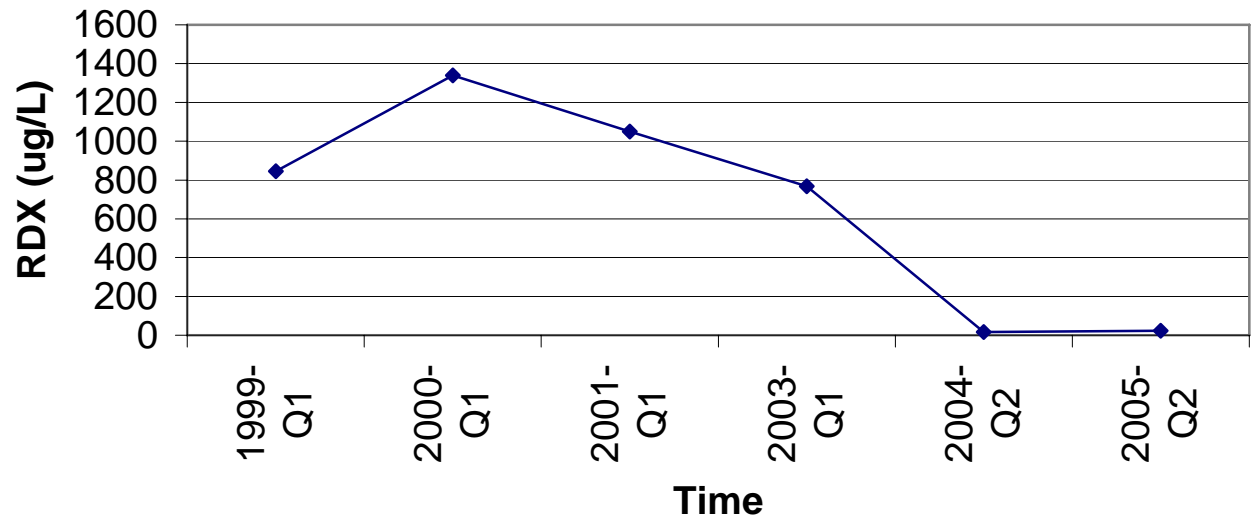
Figure 1

### RDX, PTX06-1005

To date, cleanup appears to have been effective in only one of the selected wells: PTX06-1005 (figure 1). Between 1999 and 2005, RDX concentrations dropped from approximately 1000 µg/L to 20 µg/L. This is less than the TCEQ Industrial Risk Reduction Standard 2 level of 26 µg/L<sup>3</sup>. However it is higher than the EPA lifetime health advisory of 2 µg/L<sup>4</sup>. Well PTX06-1005 is near a clean-up system injection well<sup>5</sup>. This may be the reason RDX concentrations have decreased as much as they have.

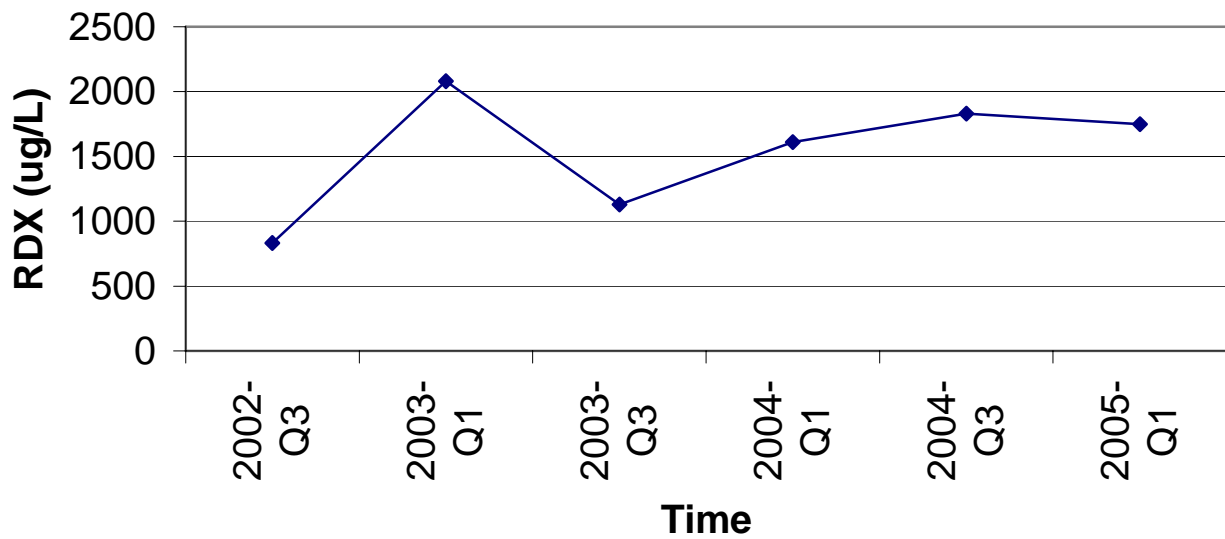
Figure 2

### RDX, PTX06-1030

RDX concentrations have declined in some wells (e.g., PTX06-1042, figure 4) and increased in others (e.g., PTX06-1046, figure 5). Still, except for well PTX06-1005, RDX concentrations remain high in all the wells (figures 2 – 7), far above any standards established to protect human health.

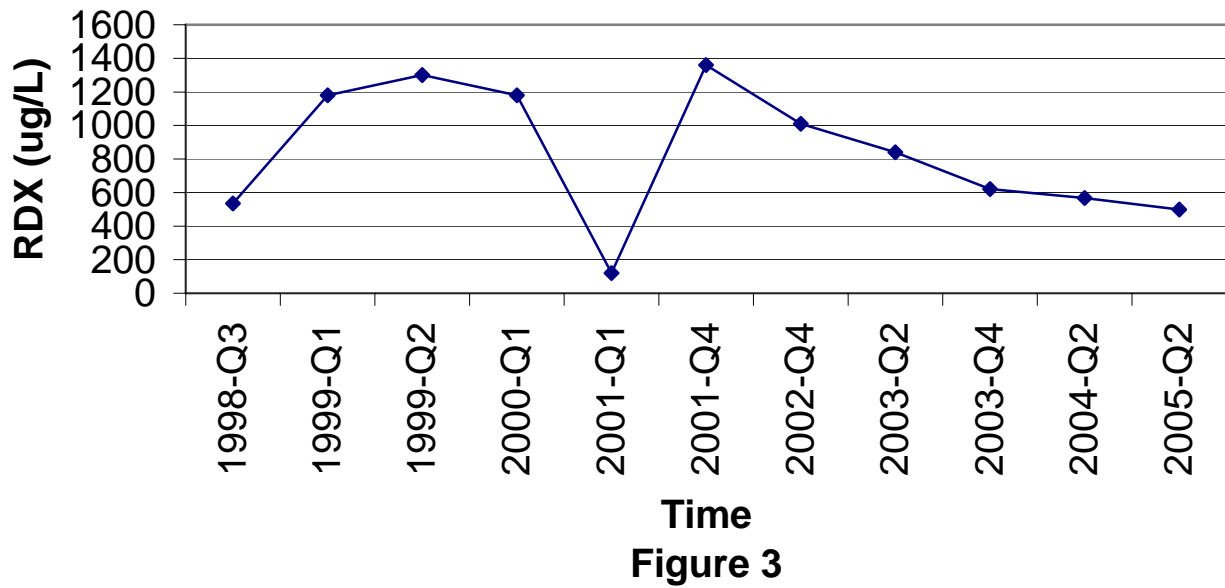
### RDX, PTX06-1039A

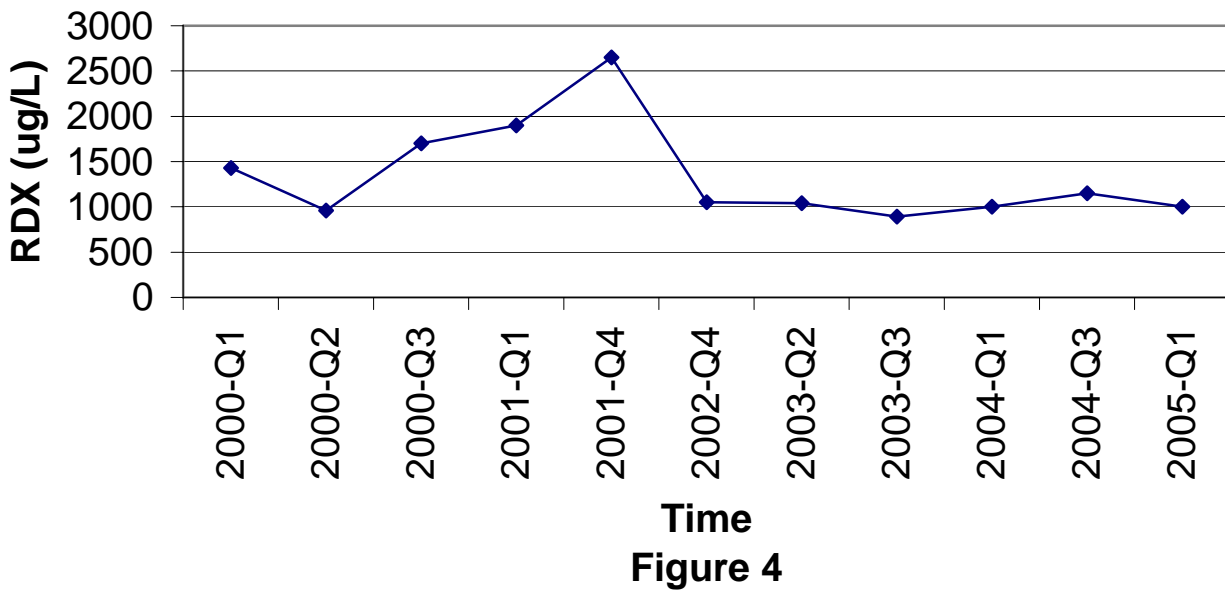
### RDX, PTX06-1042

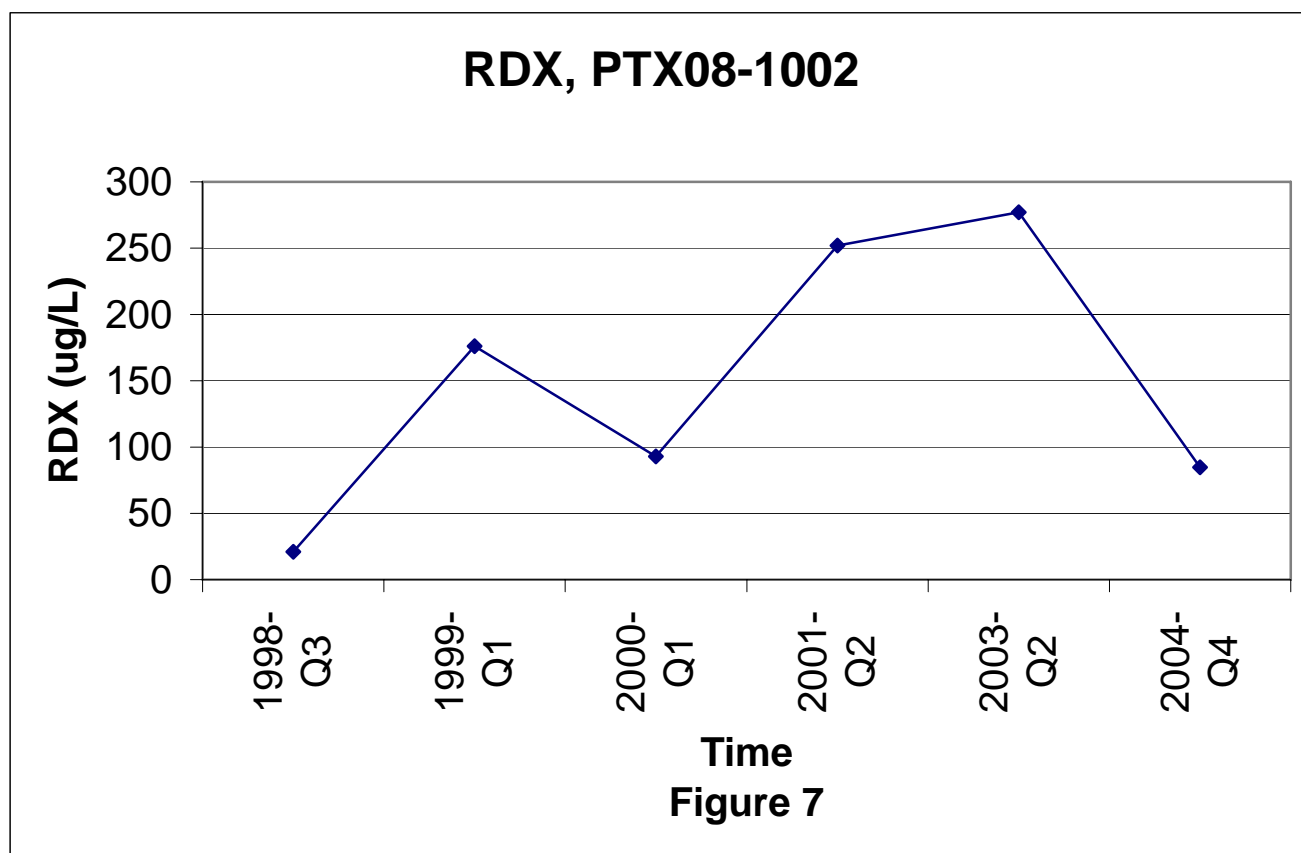
Table 1 presents RDX data for selected monitor wells in the perched aquifer. Graphs depicting the changes in RDX concentrations are presented in figures one through seven.
